### Inspection Report

### Minerals Regulatory Program

### June 28, 2012

<b>Mine Name:</b> Rockland	<b>Permit Number:</b> M0150040
<b>Operator Name:</b> Miracle Rock Mining & Research	<b>Inspection Date:</b> June 27, 2012
<b>Inspector(s):</b> Wayne Western	<b>Time:</b> 10:00 10:40 AM
<b>Other Participants:</b> None	<b>Mine Status:</b> ACT
<b>Weather Condition:</b> Hot and clear skies.	<b>Last Inspection:</b> 07-29-2008
<b>Bond Renewal Date:</b> June 24, 2014	<b>Bond Amount:</b> \$130,428.00
<b>Surface Ownership:</b> SITLA	<b>Mineral Ownership:</b> SITLA
<b>Last Year of Production:</b> 2009 13008 tons	<b>Acreage:</b> 7

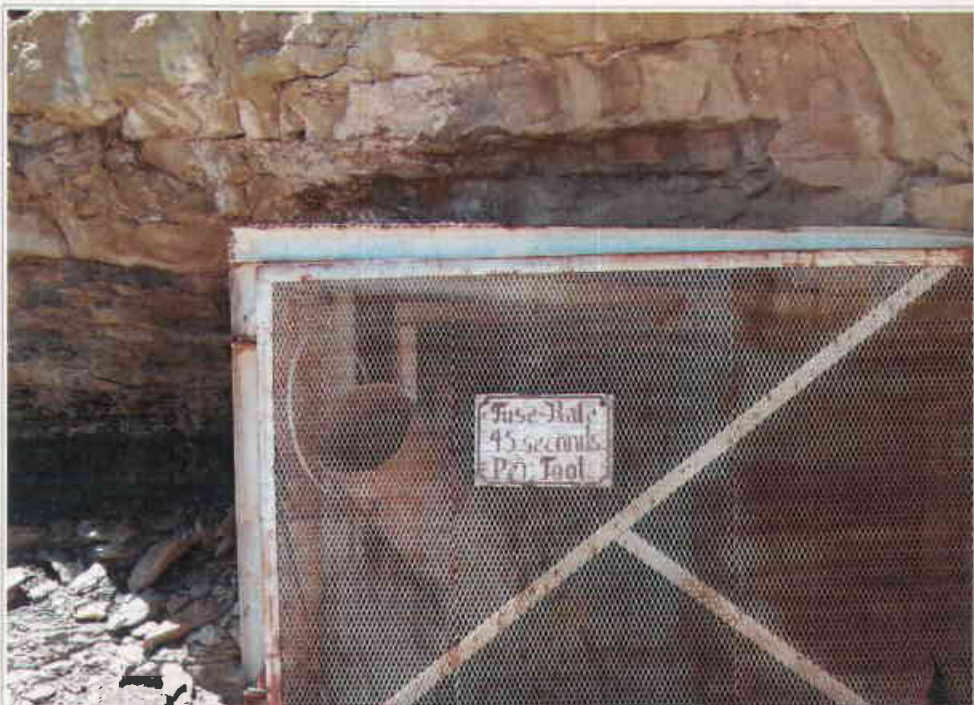
The portals were closed and locked. However, there is enough space between the barricade and rock that a person could access the mine.

East portal

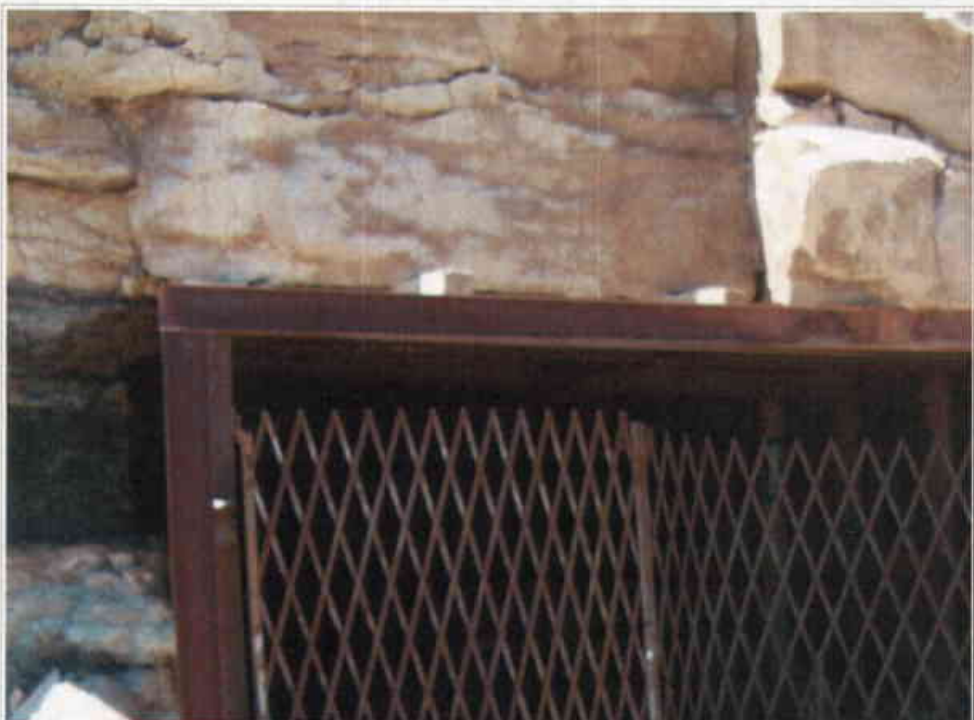
West portal

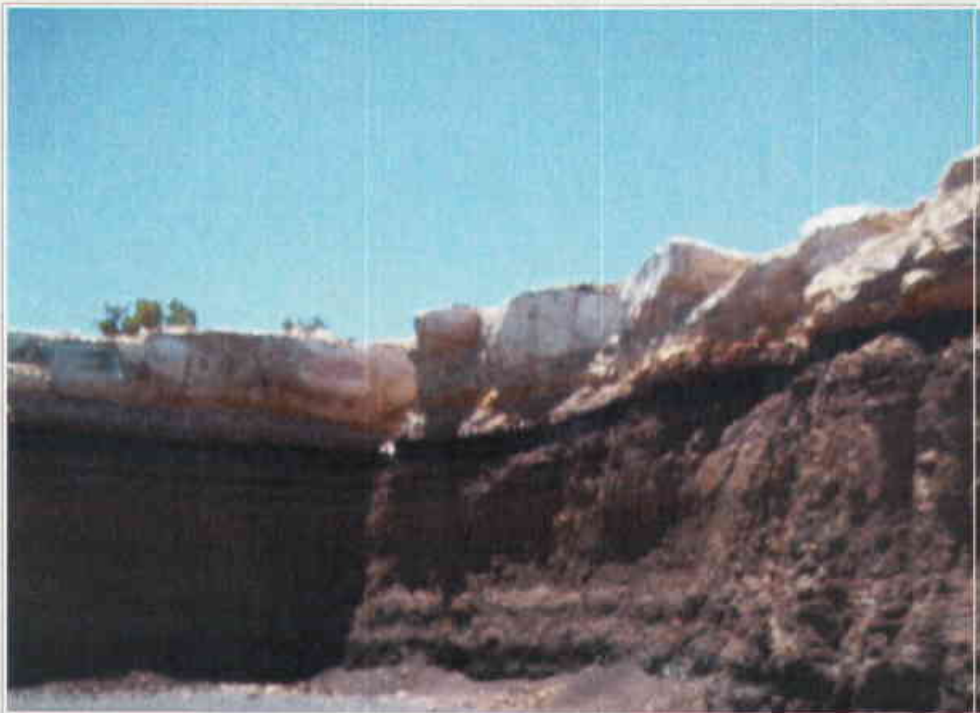
Open pit with 25 foot highwalls

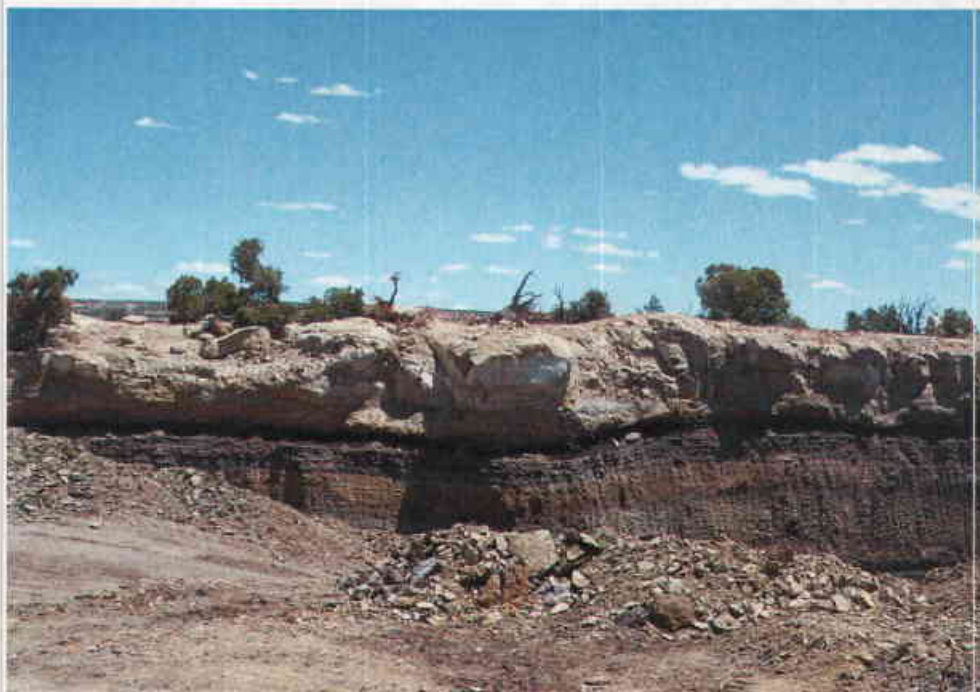
Open pit areas.
